**Re: Winchester Dam (W-1) – Inspection Summary**

This dam was inspected on October 11, 2019. I performed the inspection with Civil Engineering Specialist Arden Babb. Additionally, a site visit was made by State Engineer Keith Mills on April 11<sup>th</sup>. The Water Resources Department conducts routine inspections of the dams' exterior surfaces to identify conditions that might affect the safety of the dam. Dams are assigned a hazard rating based on downstream hazard to people and property, not on the condition of the dam. Winchester Dam is classified as a high hazard dam. High hazard dams are inspected annually.

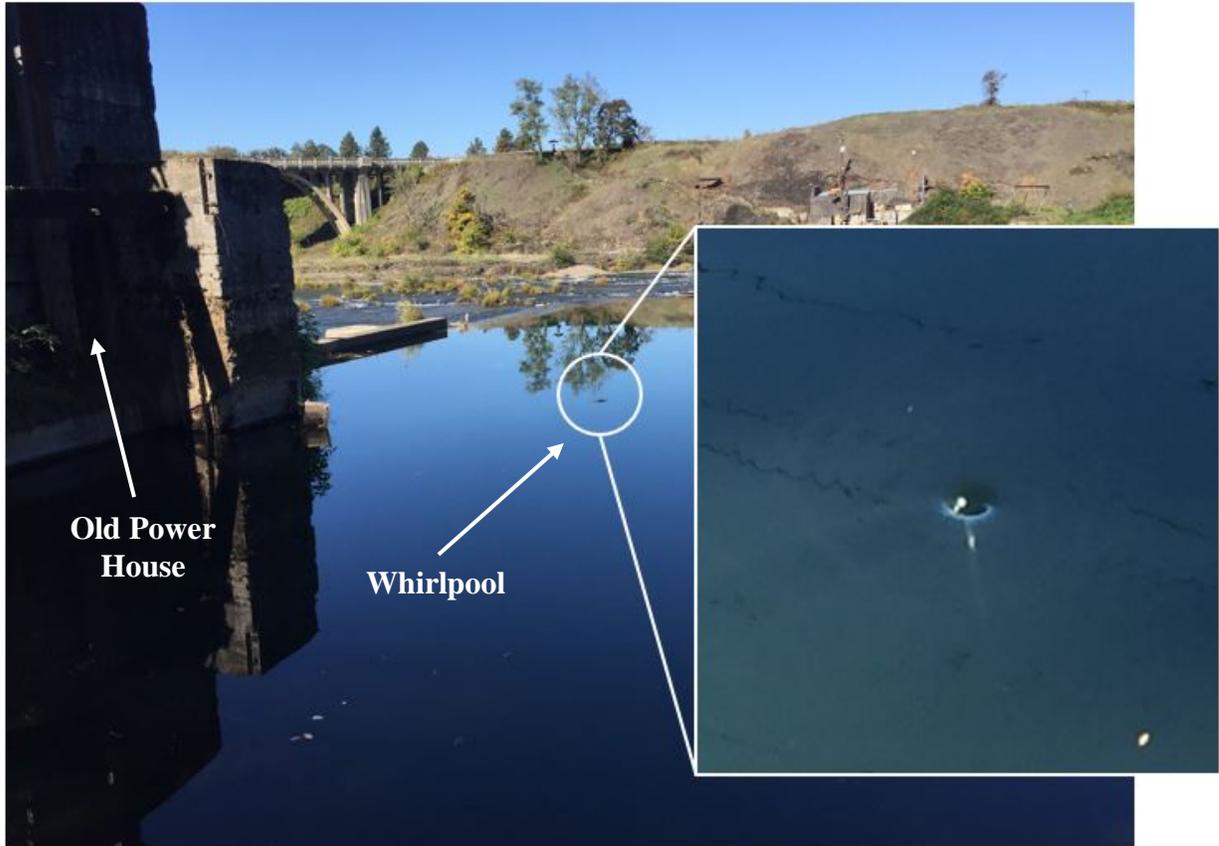
**Reservoir:** During the inspection, we observed a whirlpool near the old power house. The location of the whirlpool was a few feet upstream from where the sink hole was observed during the 2018 inspection that led to the October 2018 repair work. It was difficult to discern but it appears that the leakage from this whirlpool is coming out just downstream of the dam in the same area as it had previously prior to the repairs last October.

**Location of sink hole near the old power house**

1. Have a Professional Engineer registered in the State of Oregon that is licensed to practice structural engineering, inspect the dam structure. Contact us with the name of the engineer so that we can coordinate our next dam safety inspection with the engineer's structural inspection.
2. Routinely monitor the areas where leakage is occurring and monitor the whirlpool near the old power house for any changes. If the conditions worsen, contact us immediately.

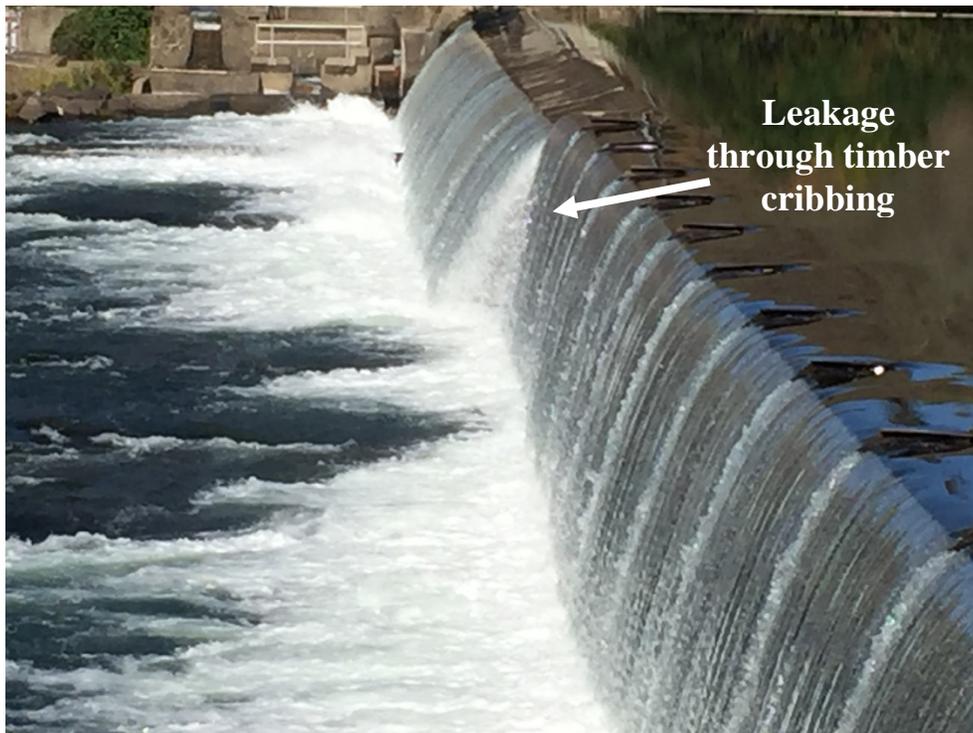
**Leakage through timber cribbing near the transition at the crest**

**Structure:** We were unable to inspect the structure of the dam because water was flowing over the dam. However, leakage through the timber cribbing can be seen at various points throughout the structure as shown in the photo above and the photo below. The timber cribbing and tie rods have a finite lifespan and portions need to be replaced from time to time. Based on our records, the structural steel and timber cribbing have not been inspected since 1987. Given the time since the last special inspection and the recommendations from that last inspection to re-examine the tie rods, a structural inspection is needed very soon. The routine inspections by this department are not intended for such detailed inspections.

The structural condition of the timber cribbing and steel tie rods need to be inspected by a qualified structural engineer. A letter was sent to you regarding this matter this past August (dated August 15<sup>th</sup>, 2019) and we have yet to hear from you. As was mentioned in the letter, if you need the name of the engineer that has performed this work for the Winchester Water Control District in the past, we can provide you with that information.

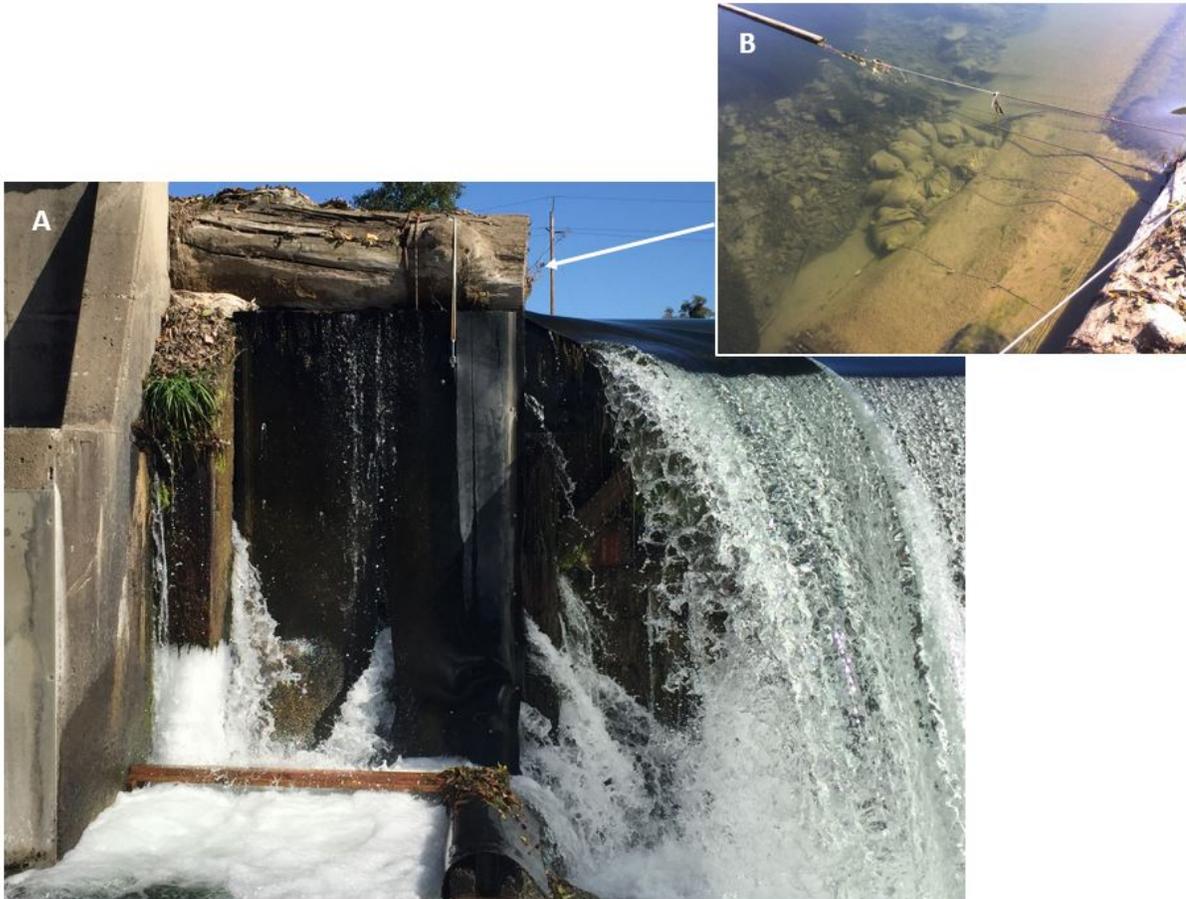
**Photo A showing leakage from sink hole (photo B) on the upstream side of the dam near the fish ladder. Both photos show the recent attempts to mitigate leakage.**

**Leakage:** There is significant leakage through the timber cribbing to the downstream side of the dam. The leakage was interfering with the operation of the fish ladder until the recent attempts to mitigate the leakage were undertaken. There is still water leaking from this area but it seems to have slowed since the work has been completed. Based on our observations during the 2018 inspection and the April 2019 site visit, this sink hole has grown significantly over the last year. Although the sand bags that were placed into the sink hole seem to have slowed the erosion of material, it is only a temporary measure and this issue needs to be addressed on a more permanent basis.

An inspection by a structural engineer will provide more information on how best to address the issue. Please note, that laws governing dam repair work have changed and prior approval by Oregon Water Resource Department (OWRD) Dam Safety may be required. Also, you may need approval and/or permits from other State and/or Federal agencies prior to starting any work. Please contact us prior to starting any work you plan to do on the dam so that we may discuss the requirements.
