**Re: Petition for Reconsideration, Fish Passage Authorization #PA-17-0138
(Winchester Dam)**

Winchester Dam Repair

WINCHESTER DAM INSPECTION AND REPAIR PROJECT
 WINCHESTER, OREGON
 WINCHESTER DAM

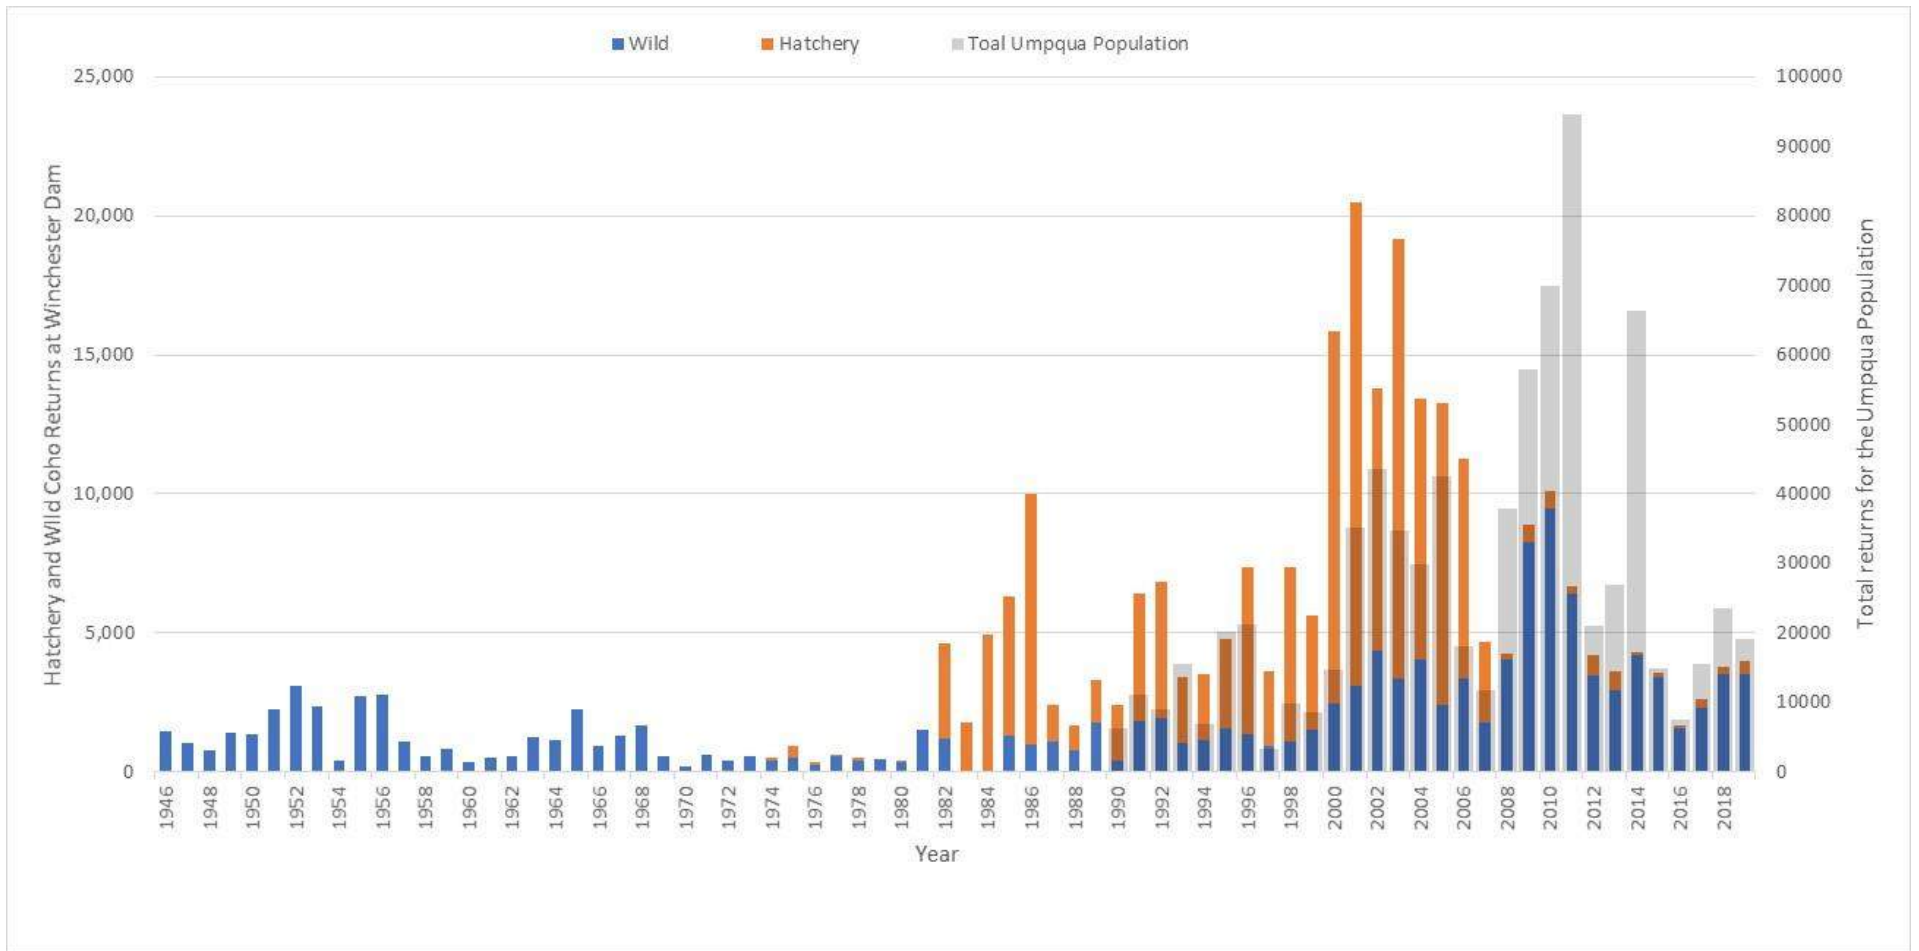
Figure 3-1: Coho passage at Winchester Dam compared to the entire Umpqua Basin population

Figure 3-1 illustrates the wild and hatchery spawner populations for the North Umpqua population, and for the ESU as a whole. Note that the data is displayed with different Y axes. Figure 3-2 illustrates the yearly and 10-year running average for wild adult Coho passage at Winchester Dam (excluding jacks).

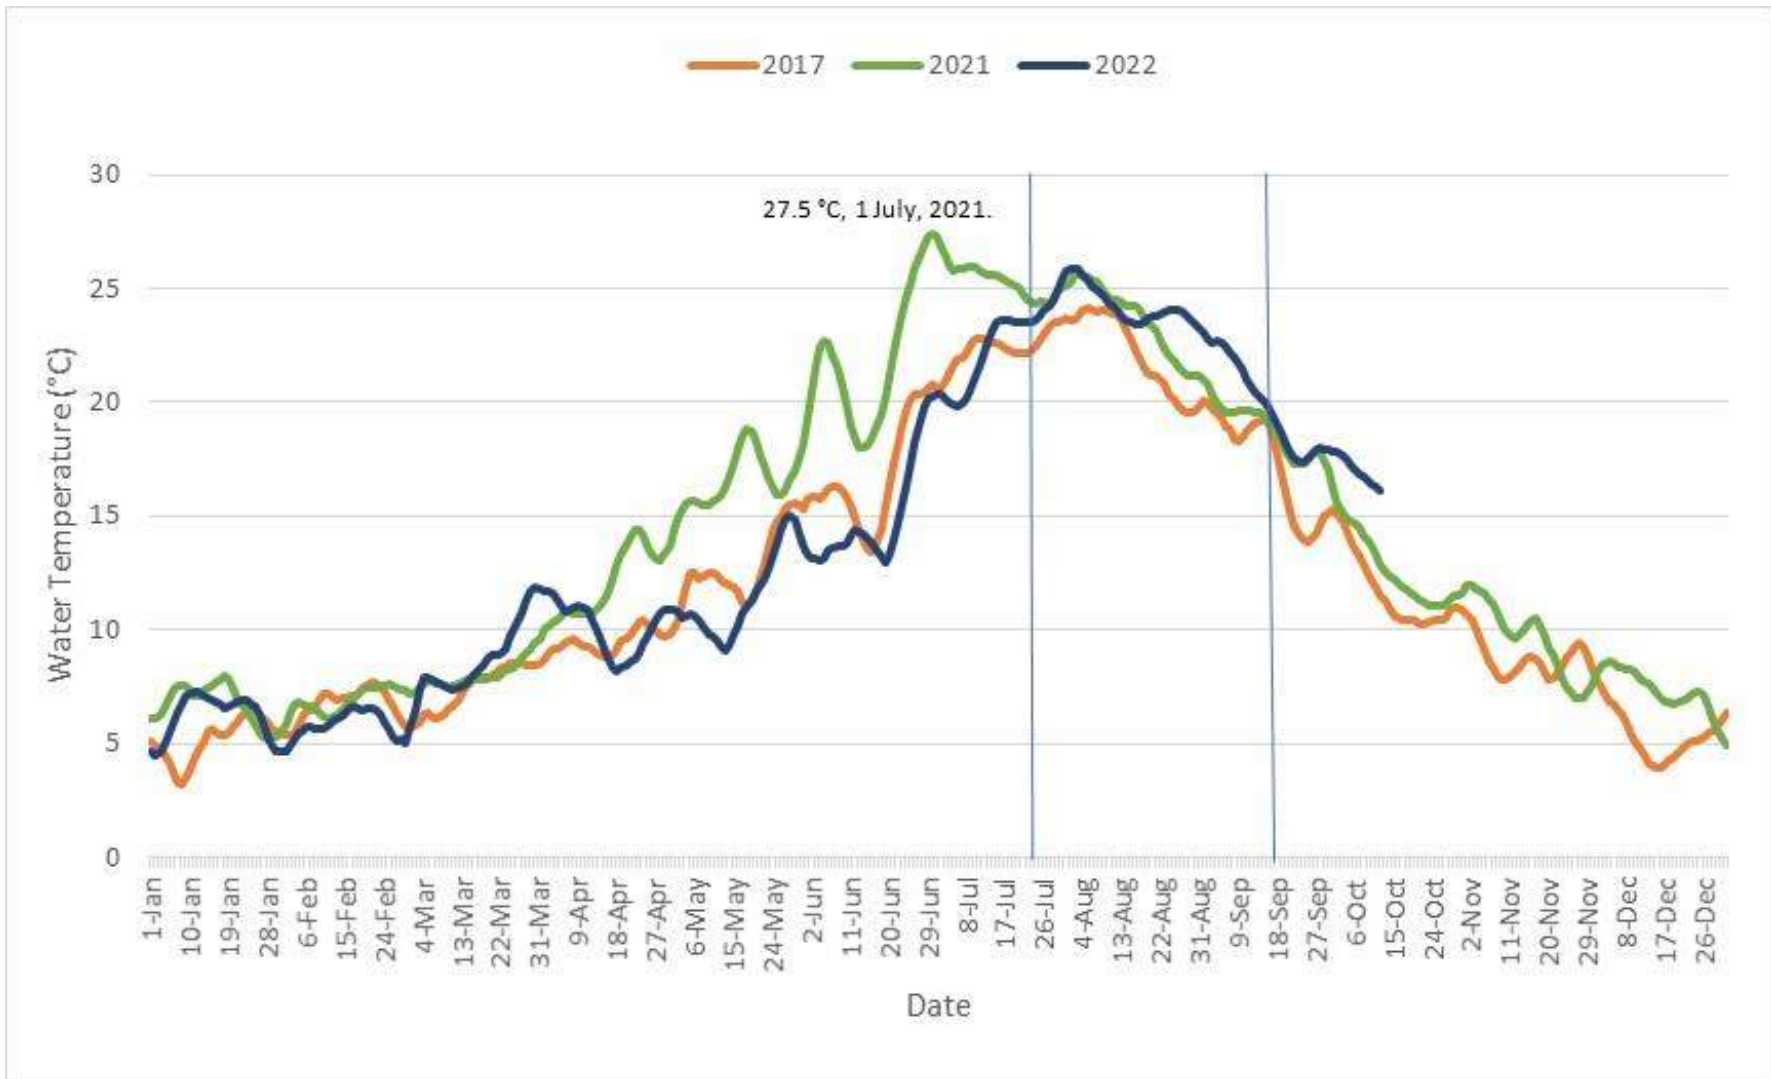
Figure 4-1: 7-day average maximum water temperatures at Winchester Dam for the coldest and warmest years on record, and for 2022 to date.

Temperature data has been recorded intermittently at Winchester Dam since 1971; unfortunately, water temperatures were not collected between October 1991 and August 2016. Figure 4-2 illustrates the 7-day average maximum temperature for three years: the hottest year since 2016, the coolest year since 2016, and 2022 to date.

Note: In water work window is indicated by blue vertical lines.

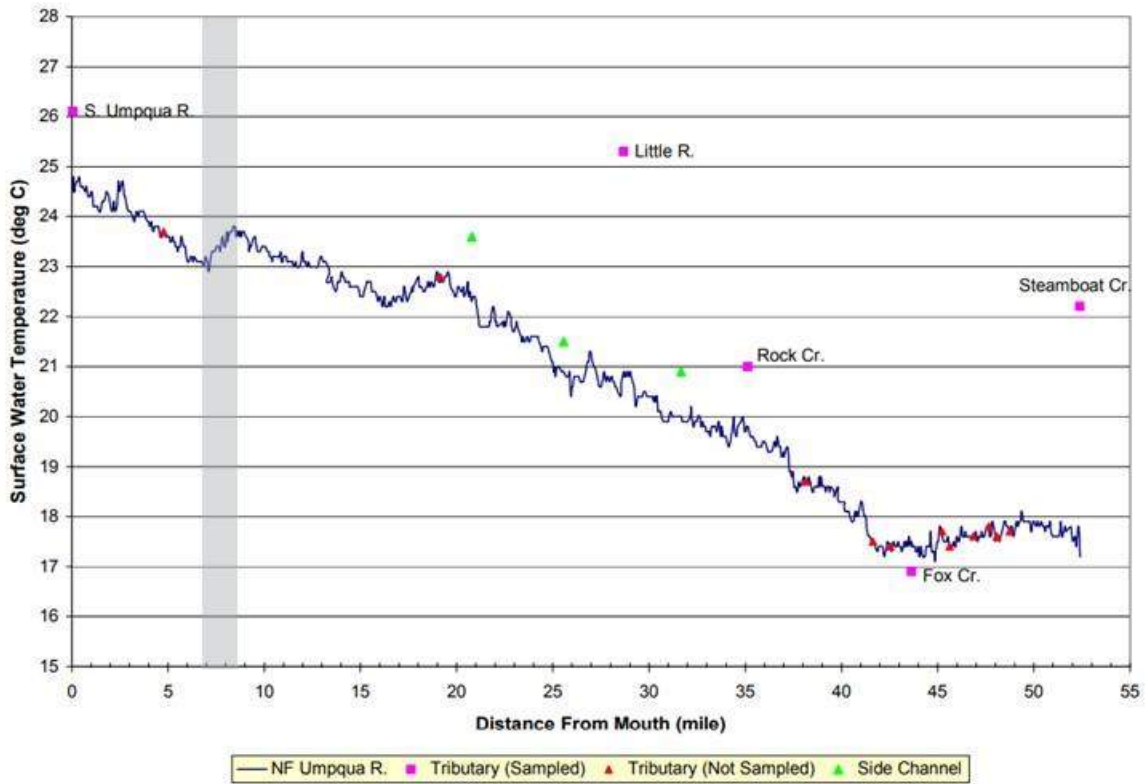
Figure 4-2: Surface water temperatures in the N. Umpqua River.

Winchester Dam and its associated reservoir presumably contribute to the water temperature Environmental Baseline. In general, reservoirs increase water temperatures by slowing the water and exposing more surface area to solar radiation. The temperature TMDL does not identify Winchester Reservoir as a contributor to elevated water temperatures in the N. Umpqua River. In fact, water temperatures collected, and infrared aerial surveys done by the Oregon Department of Environmental Quality (ODEQ) indicate that, Winchester Reservoir has a cooling effect on the River. Figure 4-3 illustrates the results of these surveys (Watershed Sciences, 2003). The gray bar indicates the location of Winchester Reservoir from approximately RM 7 to RM 8.5. A distinct cooling trend is evident from upstream to downstream in the Winchester Reservoir reach.

Note: The gray bar indicates the location and extent of Winchester Reservoir (from Watershed Sciences LLC, 2003).

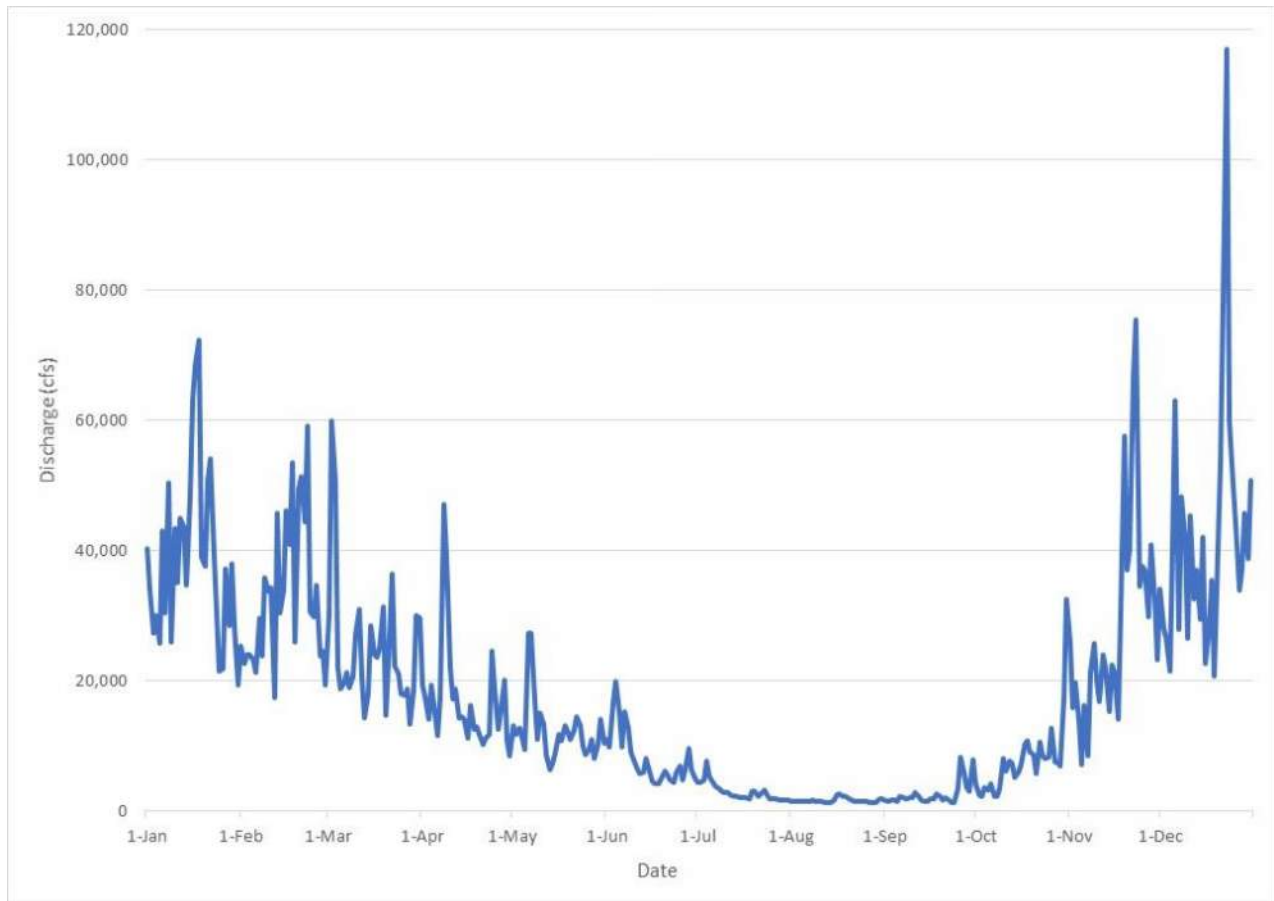
Figure 4-9: Maximum Mean Daily Discharge at Winchester.

The upstream dams of the NUHP influence flows in the North Umpqua River, but primarily in bypass reaches (river reaches around which water is diverted for power generation). Baseflows are largely unchanged from pre-project conditions in the mainstem reaches below the NUHP, and any observed changes are short-term and due to discharge variability resulting from load regulation (Stillwater 1998). Farther down in the system, at Winchester Dam for instance, these changes are likely not biologically significant, if they are detectable at all.

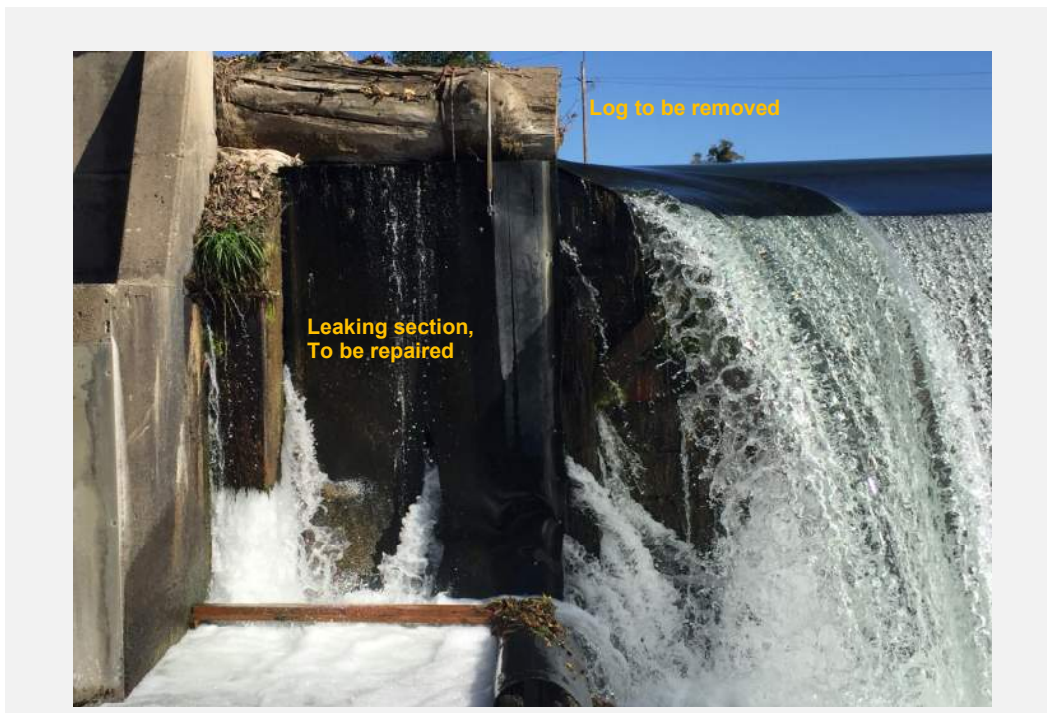
Figure A1-3: Leak creating false attraction flow at fish ladder (10/10/2019)

- 1. Repair the dam face near the fish ladder to eliminate false attractant flows.** There is currently water infiltrating the dam, and discharging near the fish ladder side entrance, potentially creating a false attraction flow. The area will be repaired with concrete following drainage of Winchester Reservoir.
